Quite a Pair: Robots Used to Reline Penstocks

Penstock Rehab

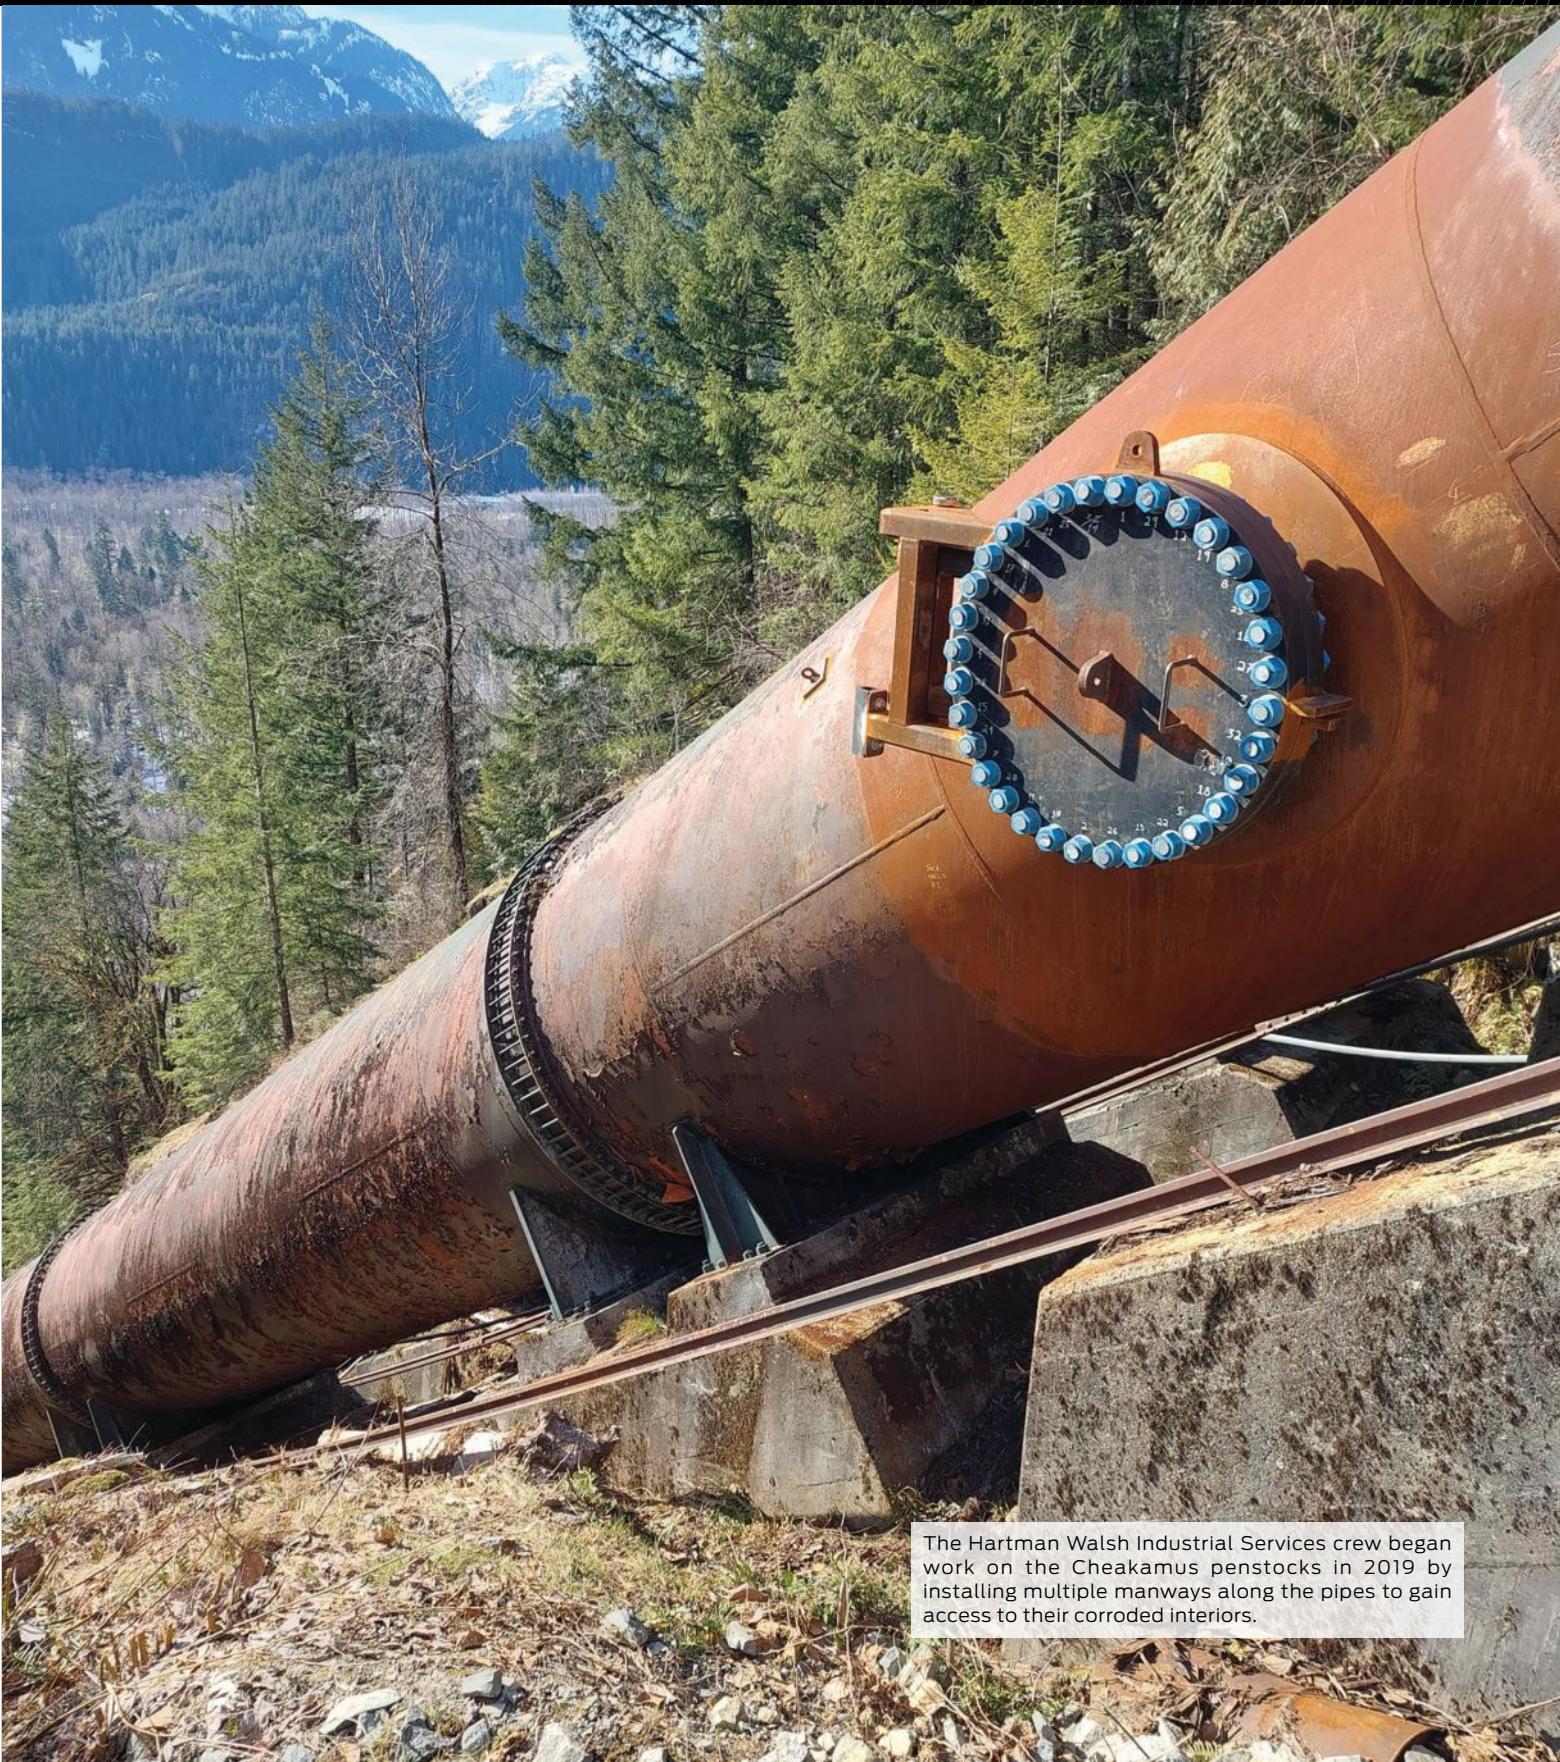
The Hartman Walsh Industrial Services crew began work on the Cheakamus penstocks in 2019 by installing multiple manways along the pipes to gain access to their corroded interiors.

Once the penstocks were accessible, Hartman Walsh began by installing four manways approximately 400–800 feet (122–244 m) apart along the pipes (depending on where roads

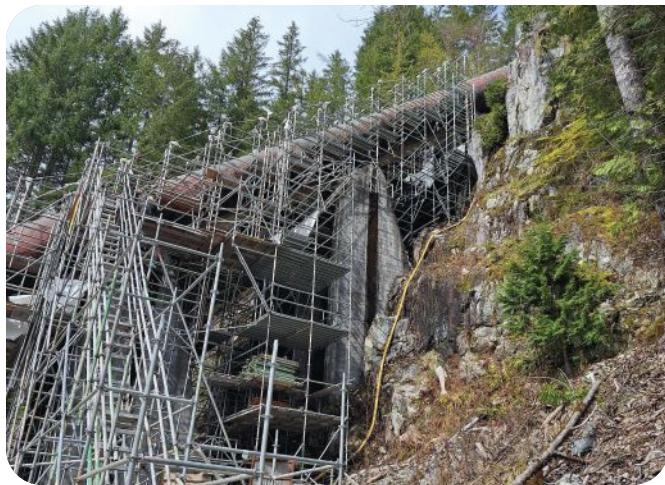
Scaffolding was constructed around the BC Hydro penstocks prior to exterior surface preparation, which included abrasive blasting operations.

With exterior-surface abrasive blasting operations also set to begin that year, Vancouver-based subcontractor Northstar Access arrived on site and installed a scaffolding system. Another Vancouver subcontractor, Elements, encased the scaffolding in a 12-mil (304.8-micron) shrink wrap containment system.

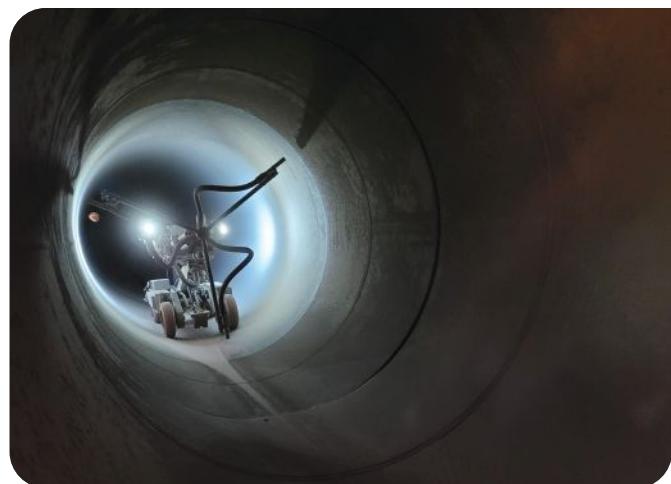
Hartman Walsh developed three multi-million-dollar, robotic blasting and coating application machines specifically for the Cheakamus penstocks' project.

Hartman Walsh brought in three proprietary, multi-million-dollar, robotic blasting and coating application machines that the company developed for use specifically on this project. "We're the only company in the United States that has [this] technology," Chism said.

Hydraulic cranes, from manufacturer Hiab, were used to move the robots into and around the jobsite. Weighing approximately 2,500 pounds (~1,134 kg) each, the versatile, unmanned robots are the first of their kind, Chism said.

The machines are affixed to a chassis and feature additional equipment — including cameras and sensors — that a crew member operates from outside the penstocks. From an on-site, shipping container-style office serving as a control center, "the operator sits and is able to view the [attached] cameras on TV screen and the control panel to tell [the machine] to turn left, turn right, start blasting, stop blasting," Chism explained.

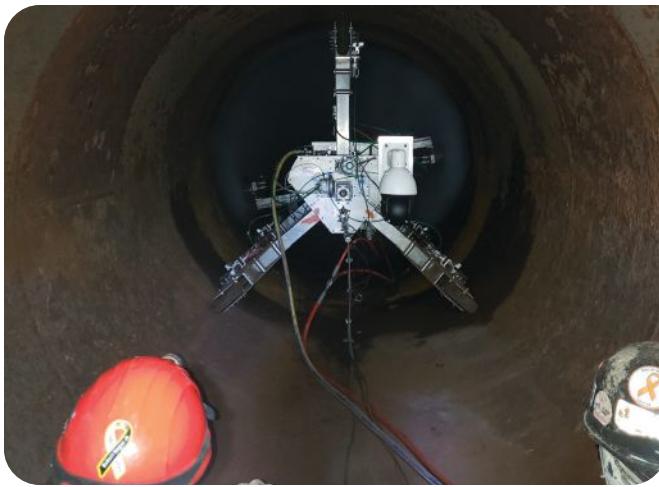
Crew members occasionally worked within the confined spaces of the penstocks' interiors, attaching winches to the robotic blasting and coating machines.

Meanwhile, other crew members work to "help tie hoses and help tie cables and attach them to winches... that are pulling the robots up and down [the pipe].... At the same time, you still [are working in] a confined space. A guy may pop in and out of there [to] make sure stuff looks right."

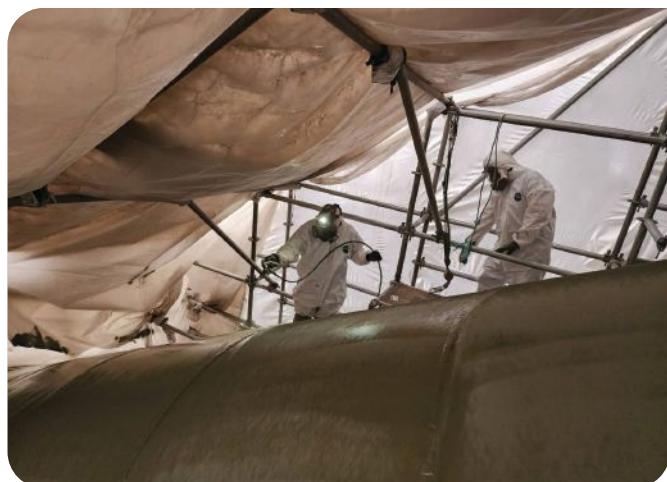
The Hartman Walsh crew worked within a shrink wrap containment system while abrasive blasting and coating the Cheakamus penstocks' exterior surfaces.

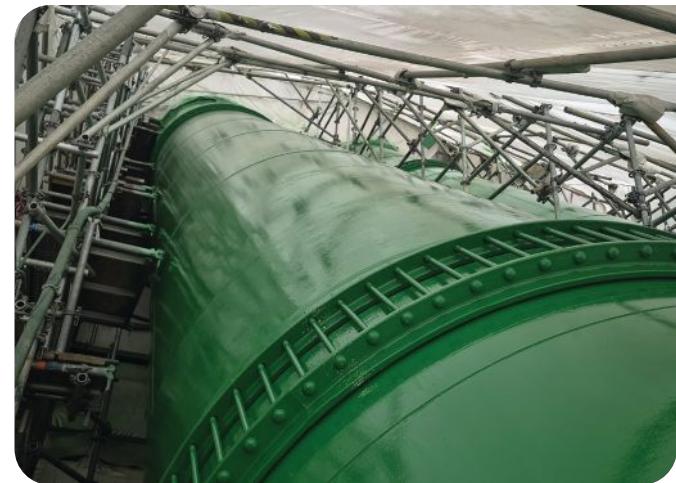
The penstocks' exterior surfaces received one coat each of Carbozinc 859 zinc epoxy primer, Carboguard635 HAR epoxy, and Carbothane 134 HG at approximately 10–20 mils.

Once abrasive blasting operations were completed, Graco airless spray pumps were used to apply on the penstocks' exterior surfaces a coat of Carbozinc 859, a fast-curing, low-volatile organic compounds, organic zinc epoxy primer.

That was followed by a coat of Carbozinc 635 HAR, an all-purpose, abrasion-resistant epoxy, and a final finishing coat of high-gloss, corrosion-resistant Carbothane 134 HG. Each coating was applied at approximately 10–20 mils (254–508 microns).
